PROPERTY CONDITION REPORT

Client(s): Mr. Sample Buyer
Property: 310 - 344 Sutton Place,
Santa Rosa, CA 95407
Realtor: Not Applicable
Date: Tuesday, September 30, 2014
Inspector: Rick DeBoard - Certification #1051
Report #: PCA7169

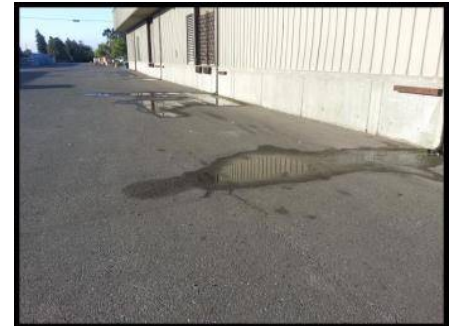
4.2 Storm Water Drainage

Water appears to pond adjacent to the structure(s) at all of the loading dock parking areas. This is probably more of a nuisance than anything else as it does not appear to get more than 1/2" to 1" deep in any one area. We recommend monitoring this condition under heavy rainfall to see if additional drainage systems are needed.

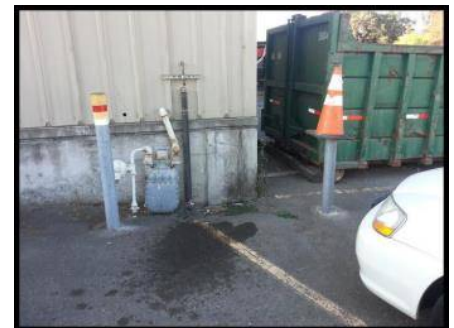
No adequate protection is installed to prevent vehicle collision at three of these meters (there are bollards, however they are placed too far apart for protection against compact vehicles). We recommend pipe bollards be installed closer together to prevent vehicles from colliding into gas pipes and/or meters. Cost-to-Cure = \$1,500.

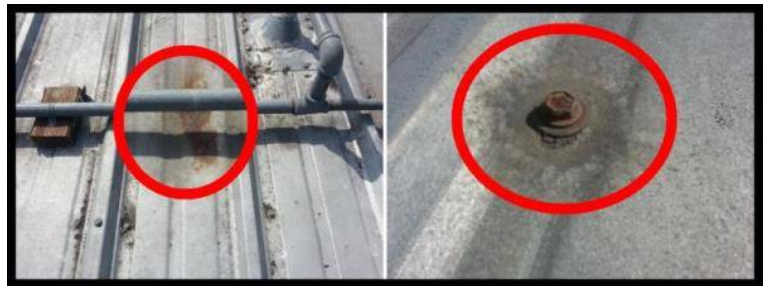
7.2 Roofing Materials

There are approximately 80% of the fasteners which have been driven too tightly into the purlins. This happens when the tension setting on the screw gun is not adjusted properly, and results in the neoprene washer being compressed to the point of damage. Since the neoprene washer is the barrier against leakage through the screw hole, this condition eventually results in leakage. We recommend that all screws which have displaced washers be replaced.

Cost-to-Cure = \$20,000.

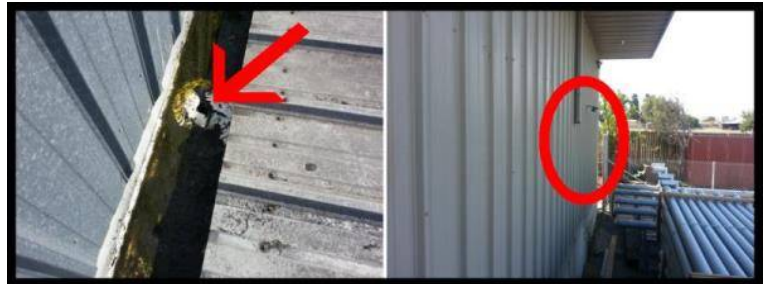
Loose/misplaced/disconnected downspouts were noted at the west side of building 330.

These are minor cost items.

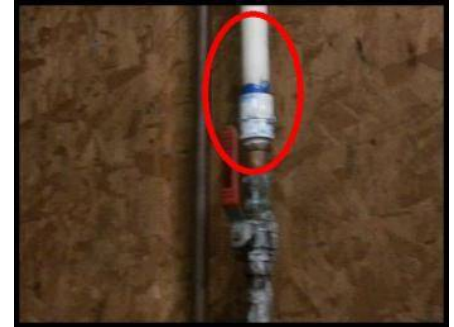
Polyvinyl chloride, (PVC), piping was noted at building 330, running up the interior north wall and all the way to the south wall (hanging under the roof framing). PVC is not allowed in commercial applications, we recommend replacing with copper).

Cost-to-Cure = \$5,000.

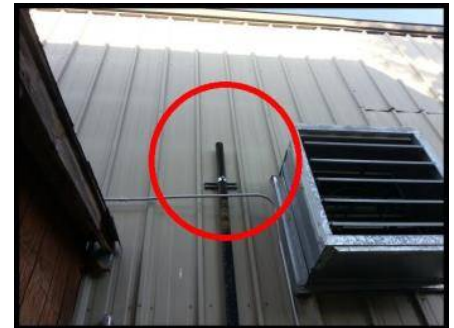
Plumbing vents are terminated improperly at the underside of the eaves at the east side of building 310. We recommend extending up above the roof line. This is a minor cost item.

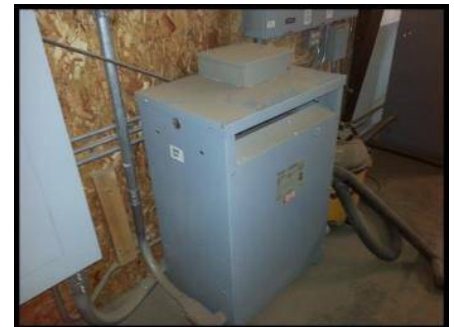
This transformer does not appear to be approved for dust environments.

We recommend further evaluation by a properly qualified commercial electrician.

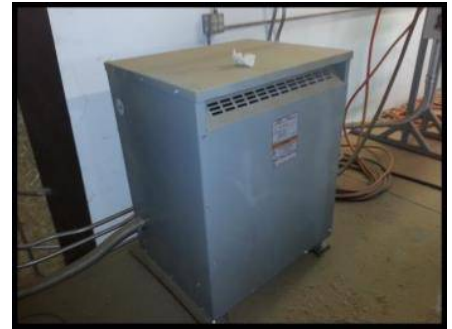
10.43 Transformer #7

Located at the wood shop of building 340. KVA (kilovolt-ampere) rating is 125. Primary Voltage is 480, secondary voltage is 277. 3 Phase. Manufactured by Jefferson.

This transformer does not appear to be approved for dust environments.

We recommend further evaluation by a properly qualified commercial electrician.

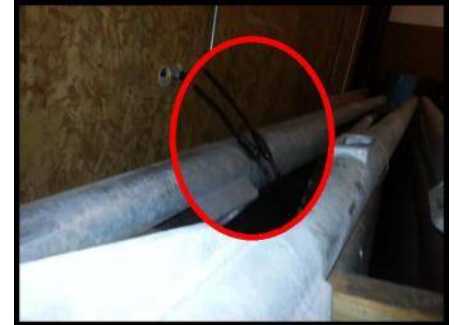
Connections were terminated without the use of junction boxes at the south interior wall of building 330. This can be a potential fire hazard, because without junction boxes the sparks which are created by loose connections or electricians tape can easily ignite nearby flammable substances. This is a minor cost item.

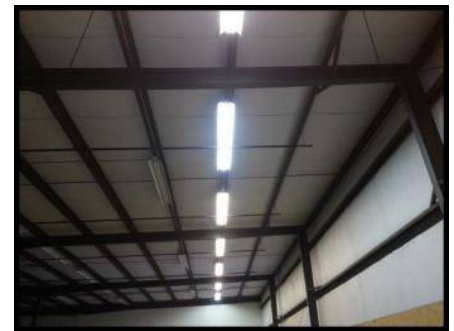
Florescent light fixtures at all buildings except 310 have no safety lens to prevent the bulbs from dropping out of the fixture. Safety covers or some type of restraint are typically required for commercial installations. We recommend that you inquire with the local building authority to see if safety lenses are required.

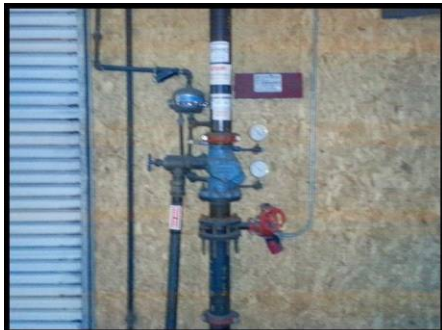
Typical of all three main risers

The inspection tag reveals that the it has been over 5 years since the last sprinkler system inspection for building 340, 342 and 344. This is in violation of current standards, and may result in severely increased fire insurance rates by your insurance carrier. The reason for this is that without a recent inspection tag present, the Insurance Service Office (the nationwide rating bureau used by all insurance carriers), can reclassify this structure as having no legally recognized fire sprinkler system installed. We recommend that you contract with a fire sprinkler maintenance firm to perform inspections per current requirements.
