PROPERTY CONDITION REPORT

Client(s): Mr. Sample Buyer
Property: 3551 - 3589 Westwind Blvd.,
Santa Rosa, CA
Realtor: Not Applicable
Date: Thursday, July 14, 2016
Inspector: Rick DeBoard - Certification #1051
Report #: PCA7361

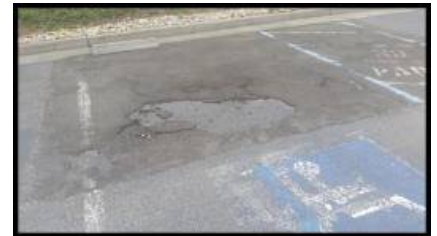
Space marking of the parking stalls is relatively poor. We recommend a fresh coat of paint be applied to the stall markings. The estimated cost-to-cure is included in the Cost-to-Cure for paving maintenance and repairs stated above.

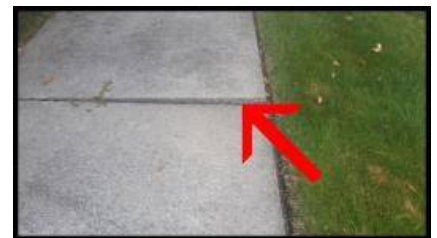
4.5 Flatwork

All walkways on the site are paved with concrete. Fair condition.

Tripping hazards were noted at three places on the public walkway, (where there is an abrupt change of 1" or more in the height of the surface). We recommend grinding the concrete to eliminate the tripping hazard. This is a minor cost item.

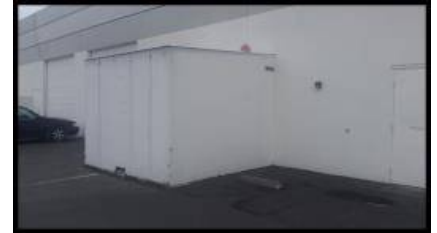
Paint/stain is near the end of its useful life at the west addition to suite 3555.

Cost-to-Cure = \$1,000.

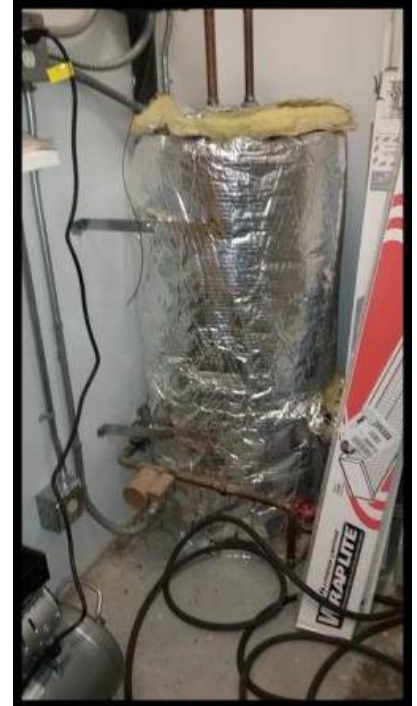
This water heater is no longer functioning and is past it's useful life.

Cost-to-Cure = \$1,500.

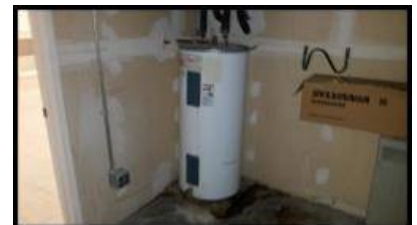
This unit appears to be 20 - 25 years old. Average water heater life in the United States is 8-10 years, although they can exceed this life expectancy

by many years if they are drained annually. You should anticipate the need to replace this/these components within the next 5 years. However, we have not listed this item in the Projected Maintenance Expenses section of this report, as we believe the expense is likely to be less than \$3,000.

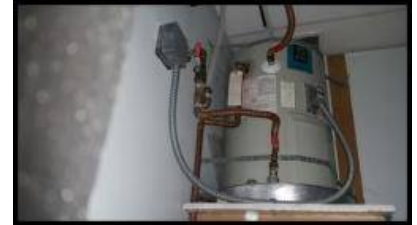
This unit appears to be 20 - 25 years old. Average water heater life in the United States is 8-10 years, although they can exceed this life expectancy by many years if they are drained annually. You should anticipate the need to replace this/these components within the next 5 years. However, we have not listed this item in the Projected Maintenance Expenses section of this report, as we believe the expense is likely to be less than \$3,000.

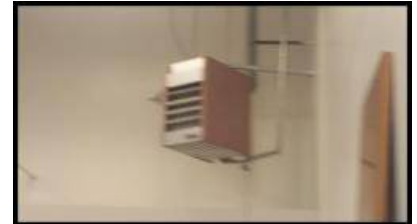
9.2 Shop Furnaces

There is one ceiling mounted shop furnace in the suite 3551 warehouse. Tenant states that this unit is functional. However, it is the original and you should anticipate the need to replace this component within the next 5 years. Projected Expense = \$5,000.

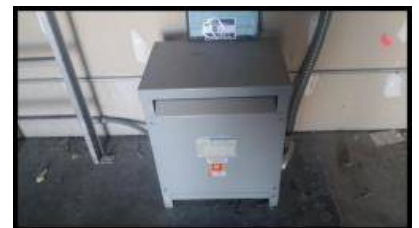
This transformer has been installed too close to the wall, as determined by the specifications on the name plate, this may not allow for proper cooling of the transformer. Since overheating is the main cause of transformer

failure we recommend that a commercial electrician examine this transformer and make corrections.

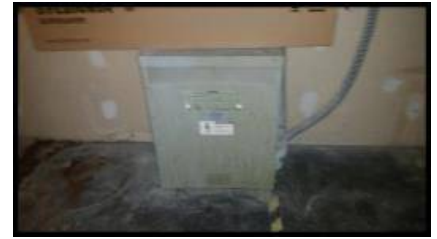
Clearance requirements are normally marked on the name plate, however no such markings were found. Typical clearances to the wall on the vented back side of the housing are 4" or more for this KVA rating to allow proper cooling of the transformer. Since overheating is the main cause of transformer failure we recommend that a commercial electrician examine this unit to establish whether it is installed according to specifications.

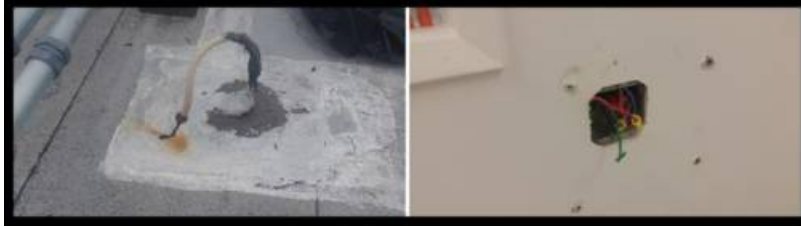
1. Connections were terminated without the use of junction boxes at the rooftop. This can be a potential fire hazard, because without junction boxes the sparks which are created by loose connections or electricians tape can easily ignite nearby flammable substances.
2. Junction or ceiling boxes were noted to be without covers at suite 3589. Although covers are inexpensive to purchase and install, they are very important because they contain any sparks within the

box in the event that wire connections become loose.
These are minor cost items.

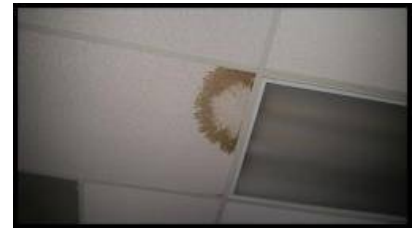
11.3 Ceilings

The majority of the ceilings are dropped down T-Bar type panels. Ceilings are in serviceable condition, with the exception of the following:
Moisture stains were noted at suite 3579 ceiling tiles. I am unable to determine if active leakage exists. See roof report for condition of roof.

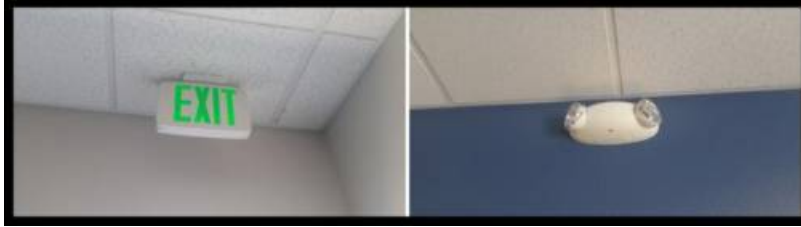
Some of the emergency exit signs and emergency exit lights we tested did not respond to the test button. We recommend these be serviced (batteries replaced and tested). This is a minor cost item.

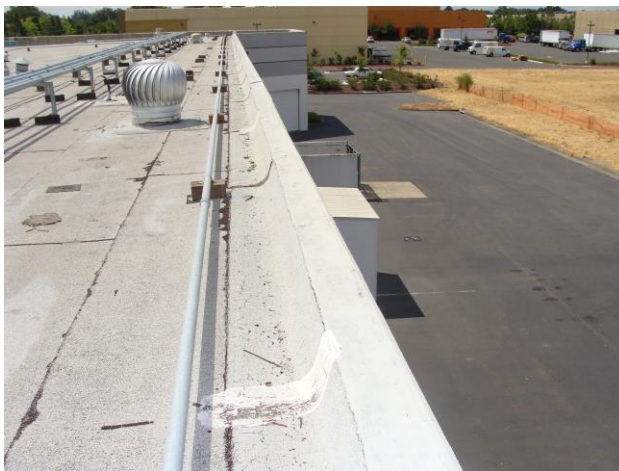
Perimeter Edge Flashing or Termination: It was noted that the parapet wall terminates at a fully adhered or glued detail. No cap metal or coping is installed at the solid concrete parapet wall.

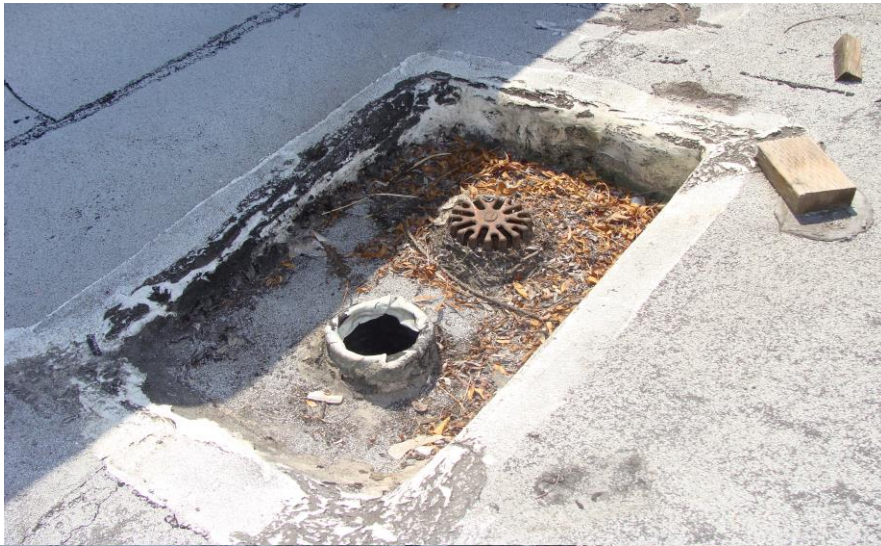
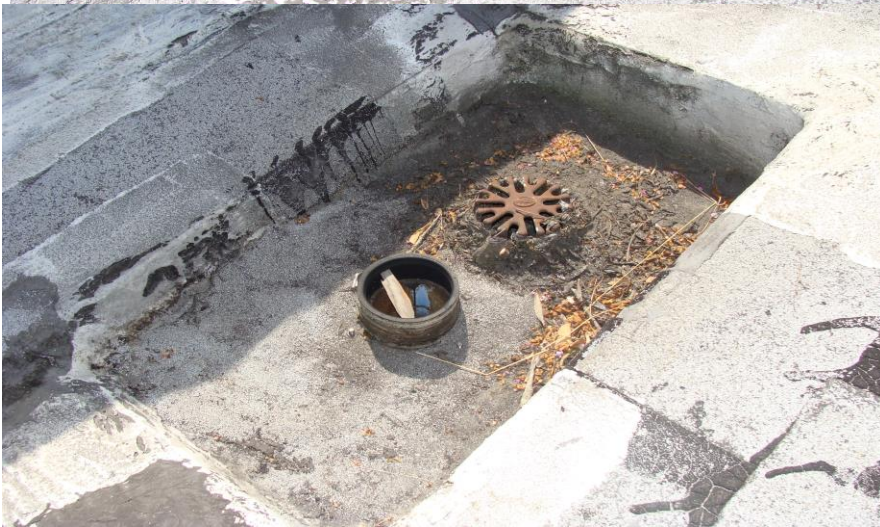
The drains are installed in recessed sumps.

Several of the overflow drains have been extended, probably because the main drains were becoming partially blocked at the drain screens and the overflows would begin to flow. By raising the overflows it would take more blockage at the main drains before the overflows would begin to flow; this probably saved on maintenance but is not a good practice.

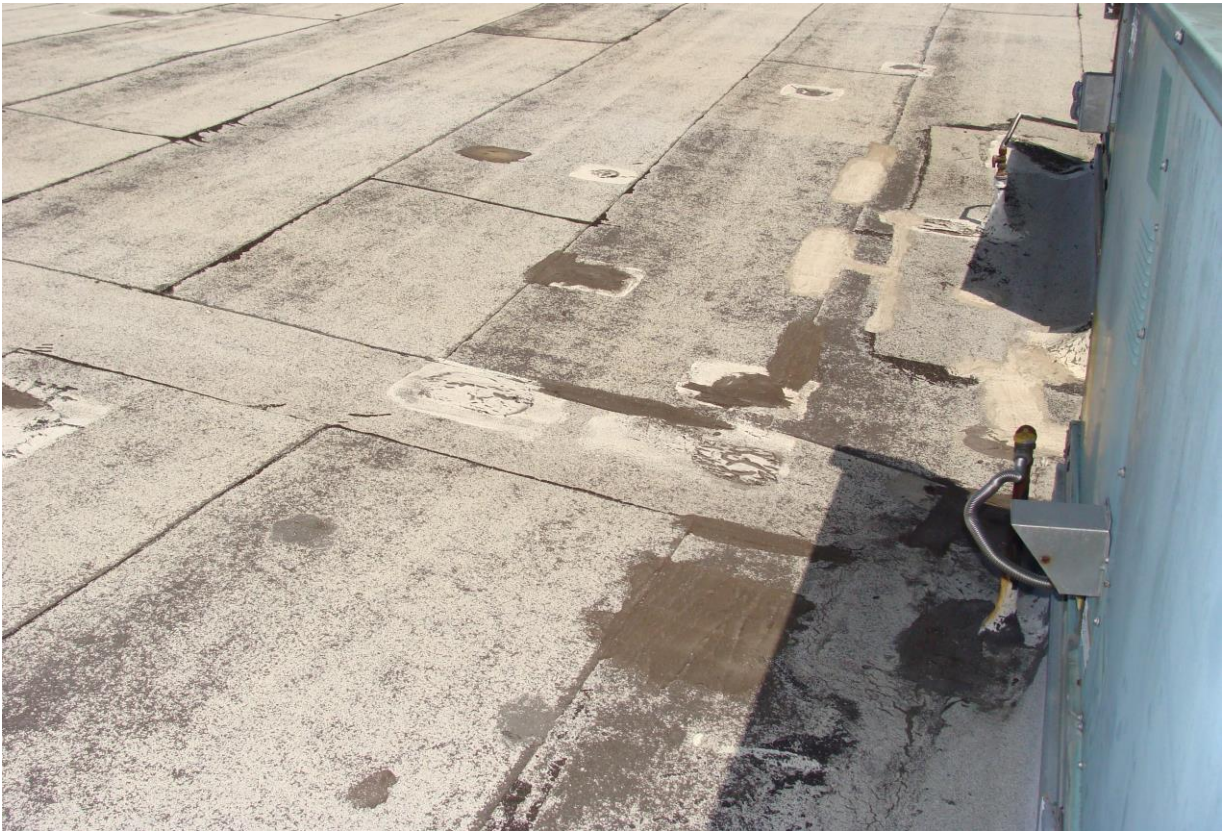
Mineral Roof surface:

Major loss of granules at the mineral surface was noted as would be expected with a roof system of this age.

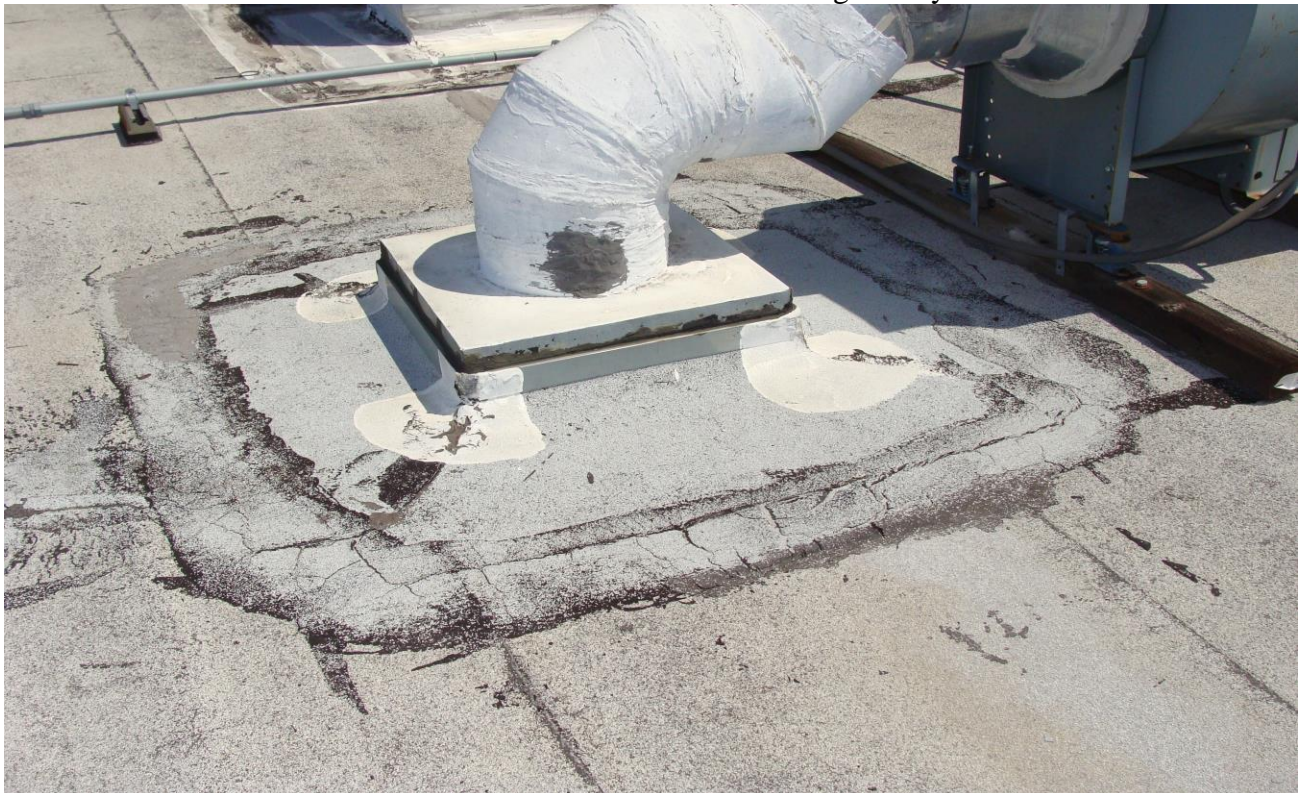
Several units and ducts have been installed after the existing roof system was installed.

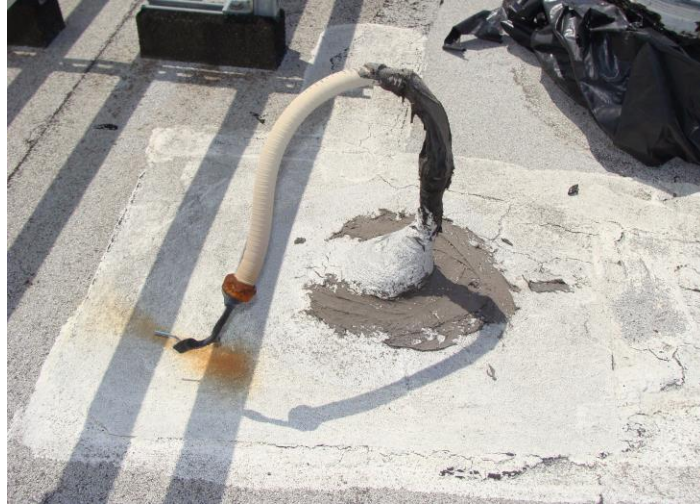
Numerous abandoned conduits, pipes and units were noted:

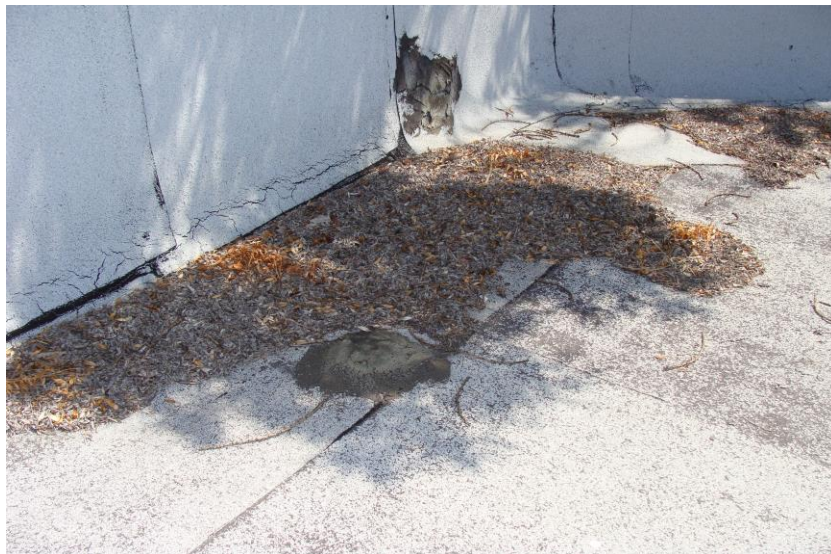
Built up Debris:

A minor amount of leaf debris from trees to the north of the building were noted.

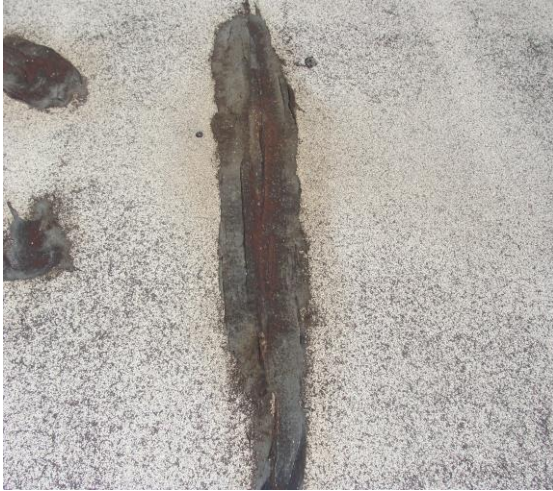
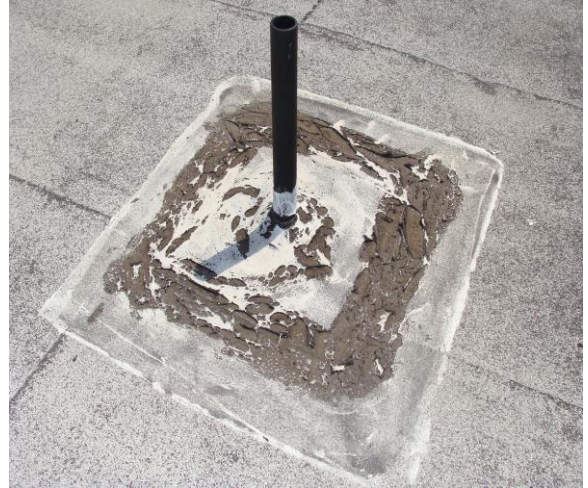
Many repairs to the roof surface have been made with unreinforced asphalt mastic and lack a protective layer of U.V. Resistant coating and are there by failing.

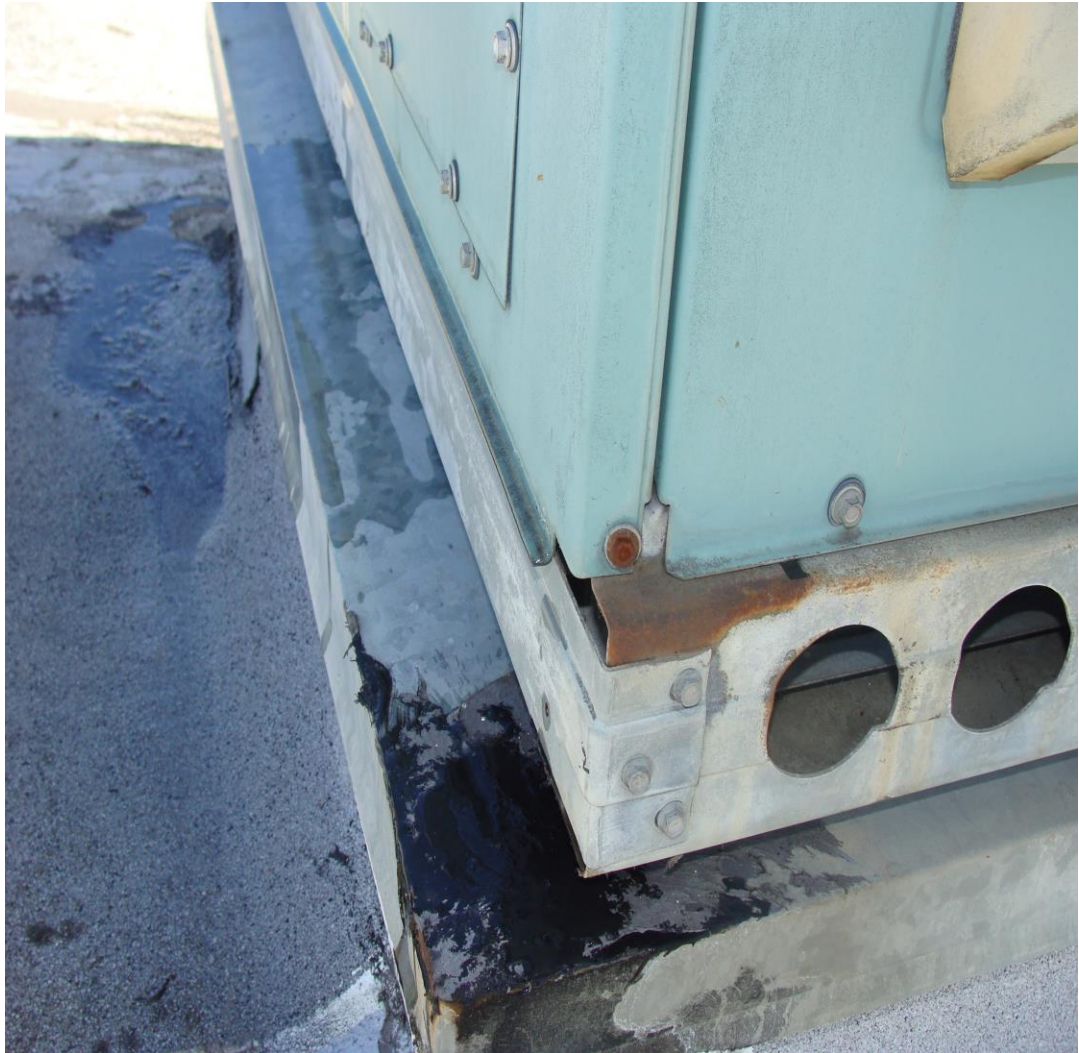
The A/C units lack condensation drain lines to carry the A/C condensation run off to the main roof drains. Several of the units are not draining from the drain fittings; rather they are draining from random places around the unit. This sort of problem can lead to condensation draining directly into the building via the A/C units.

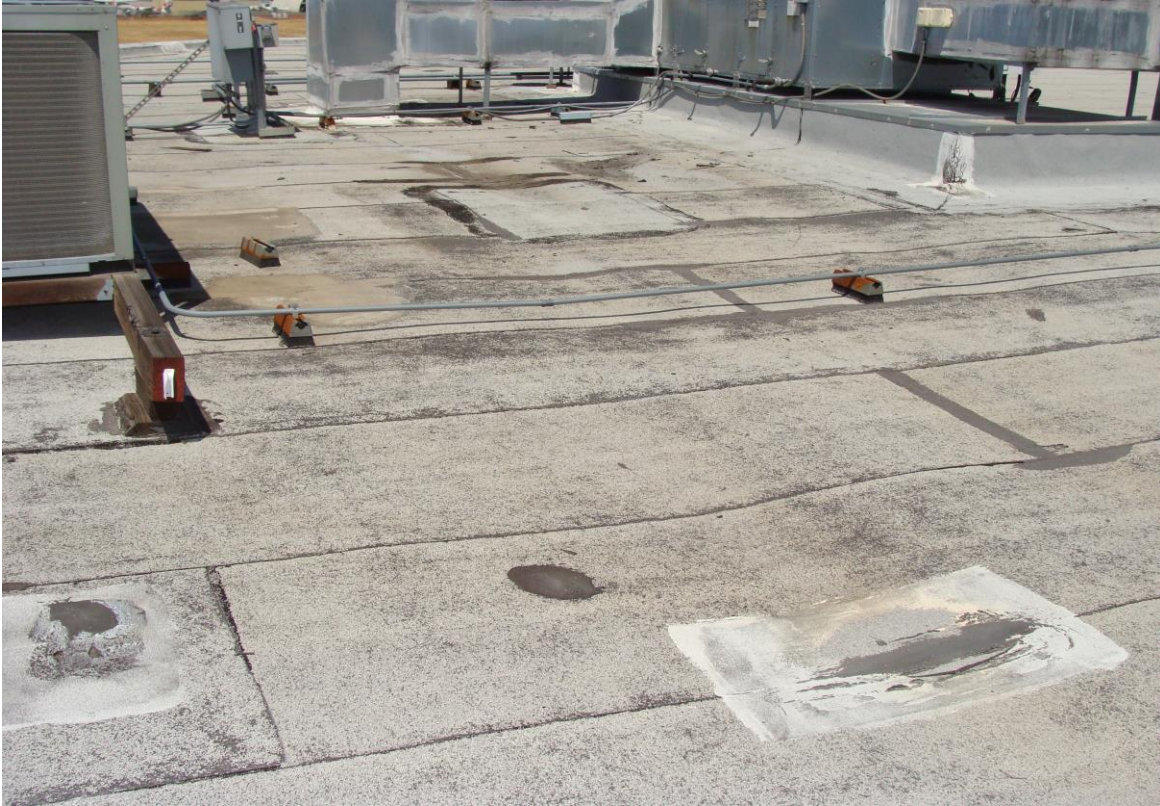
Area of roof sheathing failure:

This area near the large air exchange unit is of greatest concern. The roof sheathing in this area is failing. The roof sheathing is Oriented Strand Board or OSB and has apparently been affected by some amount of water intrusion. The sheathing in this area is soft and sagging between the roof joists. Signs of repairs and signs of ponding water were noted.

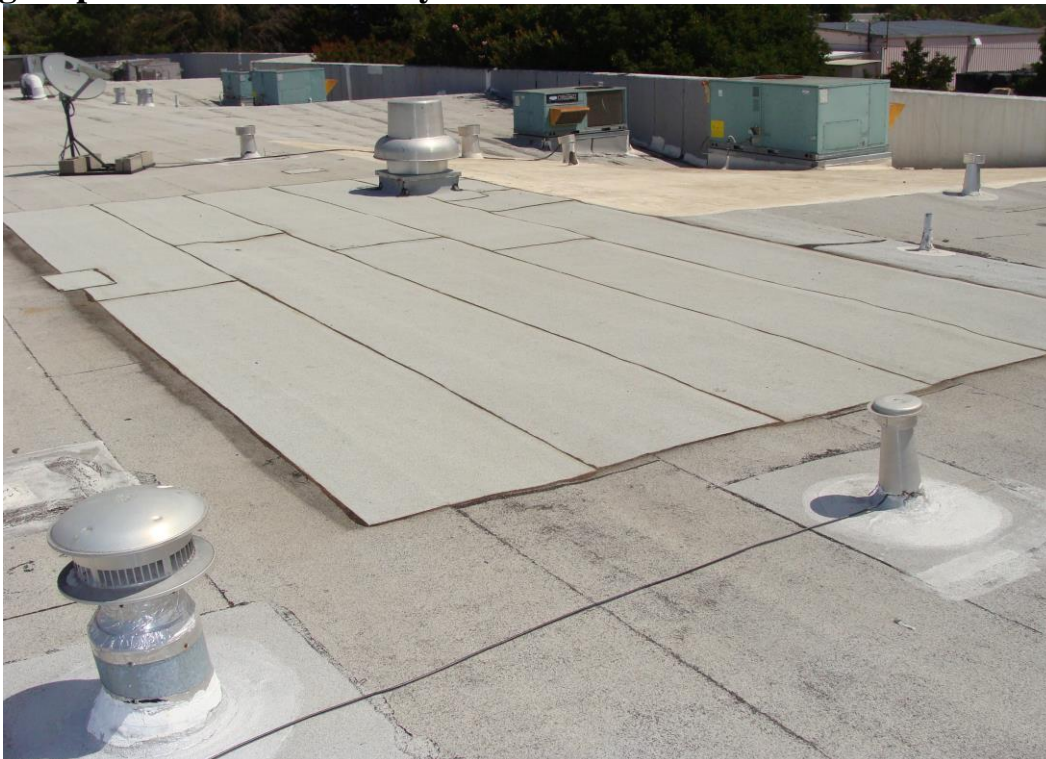
There are two areas that have been over-layed with new roof systems. The one above is approximately 500 sq ft and is a modified torch down system. The one below is approximately 700 sq ft and is a silicone roof coating system.
