PROPERTY CONDITION REPORT

Client(s): Mr. Sample Buyer
Property: 310 - 344 Sutton Place,
Santa Rosa, CA 95407
Realtor: Not Applicable
Date: Tuesday, September 30, 2014
Inspector: Rick DeBoard - Certification #1051
Report #: PCA7169

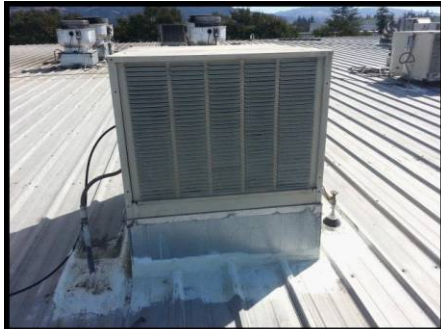
Typical Adobe Air Evaporative Coolers

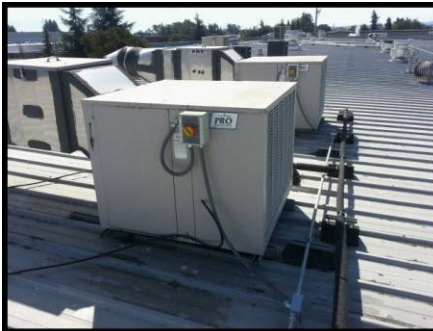
Typical Phoenix Evaporative Cooler

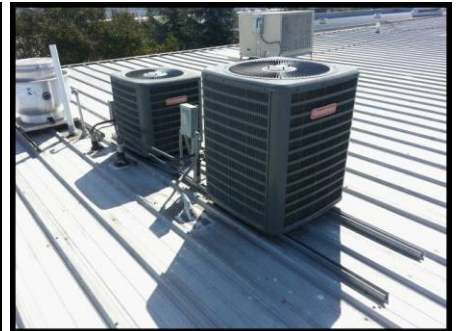
Typical Goodman A/C units

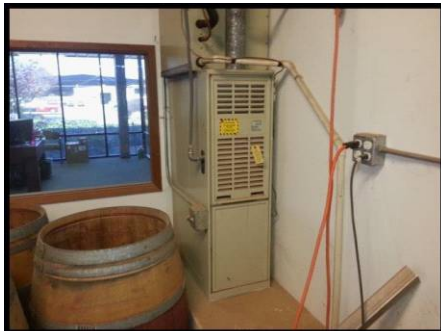
Day & Night gas furnace

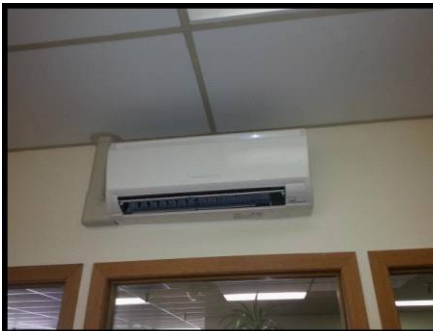
Mitsubishi Mini-Split Heat Pump

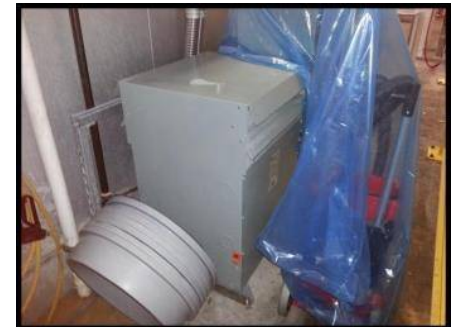
10.37 Transformer #1

Located at the east interior wall of building 310. KVA (kilovolt-ampere) rating is 75. Primary Voltage is 480, secondary voltage is 208/120. 3 Phase. Manufactured by Hammond.

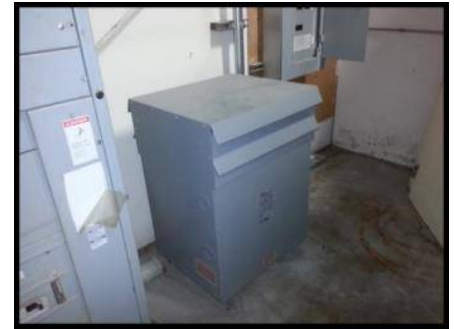
10.38 Transformer #2

Located at the old electrical room of building 310. KVA (kilovolt-ampere) rating is 75. Primary Voltage is 480, secondary voltage is 208/120. 3 Phase. Manufactured by Hammond.

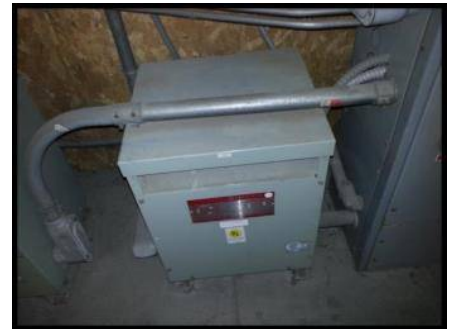
10.44 Transformer #8

Located at the west interior wall of building 344. KVA (kilovolt-ampere) rating is 15. Primary Voltage is 480, secondary voltage is 208. 3 Phase. Manufactured by General Electric.

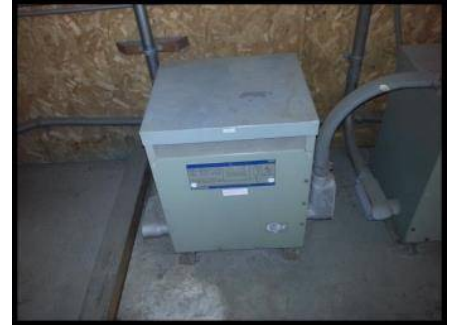
10.45 Transformer #9

Located at the west interior wall of building 344. KVA (kilovolt-ampere) rating is 15. Primary Voltage is 480, secondary voltage is 208. 3 Phase. Manufactured by General Electric.

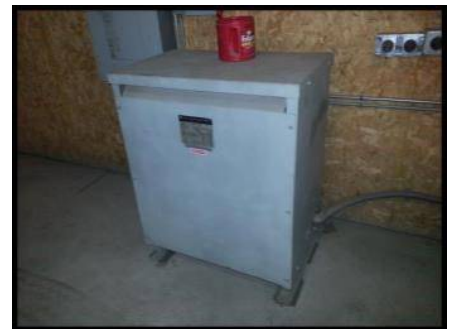
10.46 Transformer #10

Located at the south interior wall of building 344. KVA (kilovolt-ampere) rating is 75. Primary Voltage is 480, secondary voltage is 240. 3 Phase. Manufactured by MGM.
