PROPERTY CONDITION REPORT

Client(s): Mr. Sample Buyer
Property: 3551 - 3589 Westwind Blvd.,
Santa Rosa, CA
Realtor: Not Applicable
Date: Thursday, July 14, 2016
Inspector: Rick DeBoard - Certification #1051
Report #: PCA7361

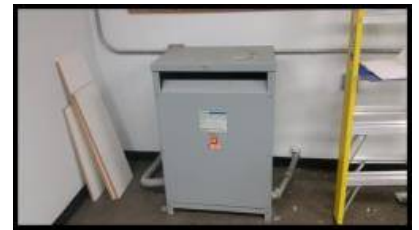
10.22 Transformer #4

Located at suite 3573. Manufactured by General Electric. Rated at 45 KVA (kilovolt-ampere). Primary Voltage is 480, secondary voltage is 208/120. Location of Primary protection is at Panel #11. Location of the secondary main breaker is panel #13. Impedance is 4.9% @ 150 degrees centigrade.

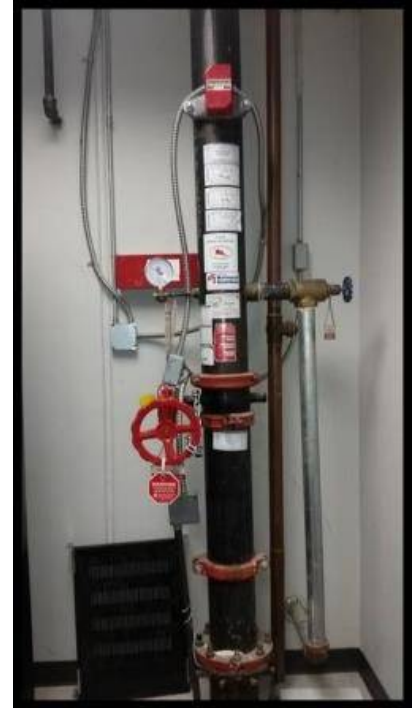
A fire sprinkler system is installed for this structure, but inspection of these components is beyond the scope of this assessment. Records on site state that periodic inspections by a fire sprinkler company have been made at the required intervals.

The main riser for the sprinkler system is located at the west interior wall of suite 3555.

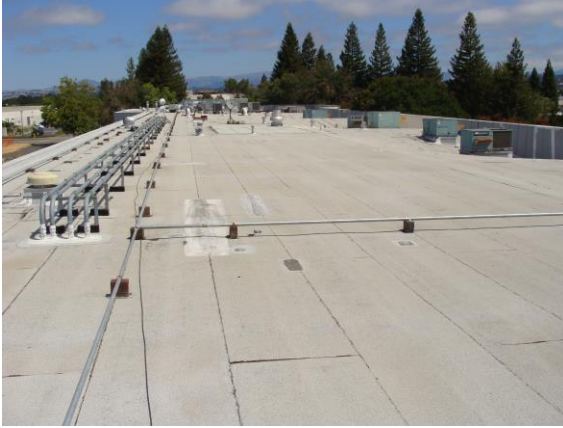
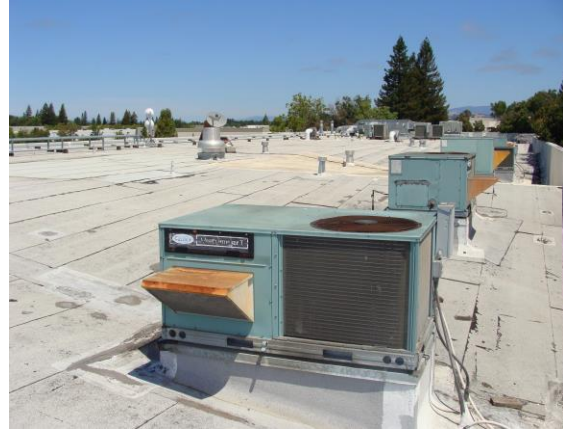
Low slope system:

- A low slope, built-up asphalt and fiberglass ply sheet membrane with a mineral surfaced cap sheet.

A visual inspection of the surface shows the membrane to be in poor condition. Estimated age of the existing roof to be 20 or more years. Areas of concern are noted below.

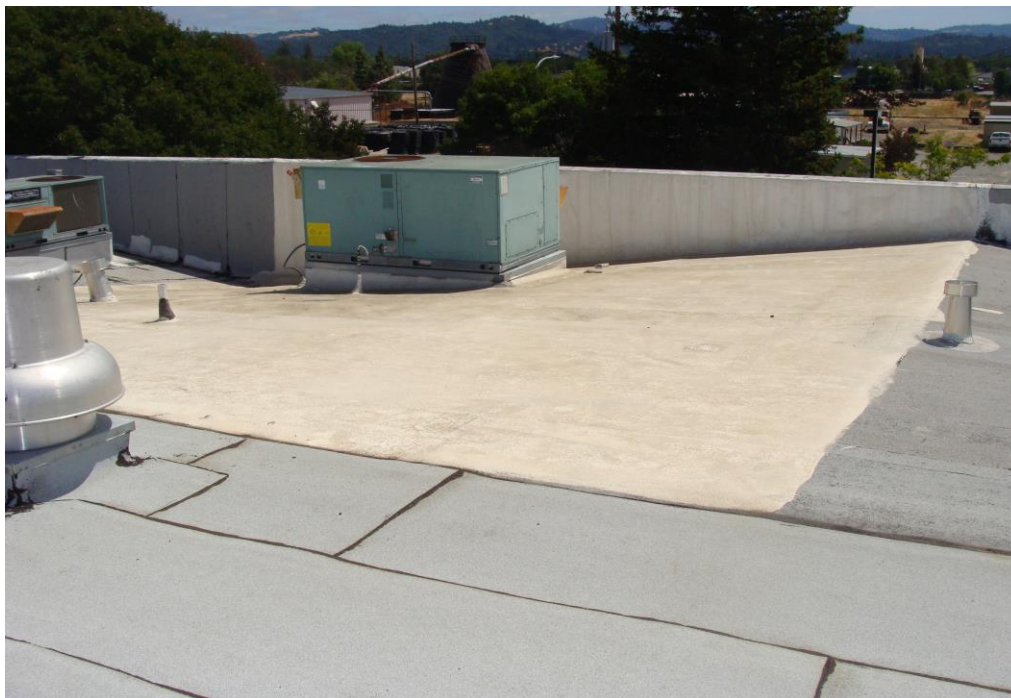
The roof system installed on this building appears to be in poor condition with almost no exceptions.
